# Characterization of dam breaching following overtopping

## Abstract

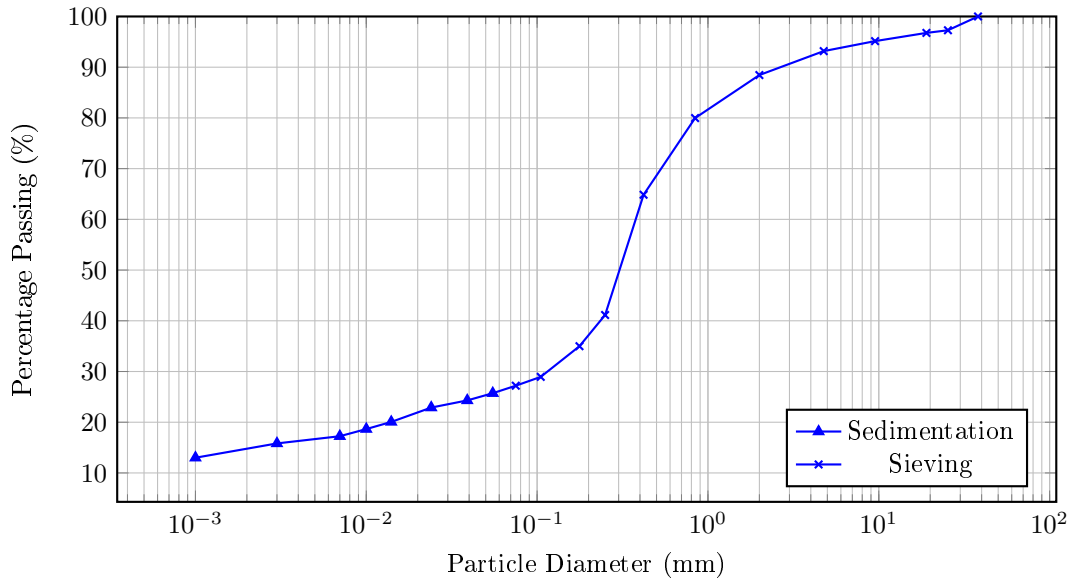
Figure 1: Grain-size distribution curve of the soil in study.

The embankment models built to perform the two dam-breach experiments used only one type of soil. The specific gravity ( $G_s$ ) was measured with a pycnometer ( $G_s = 2.64$ ). The grain-size distribution curve was built from sieve and sedimentation analysis and is shown in figure 1.

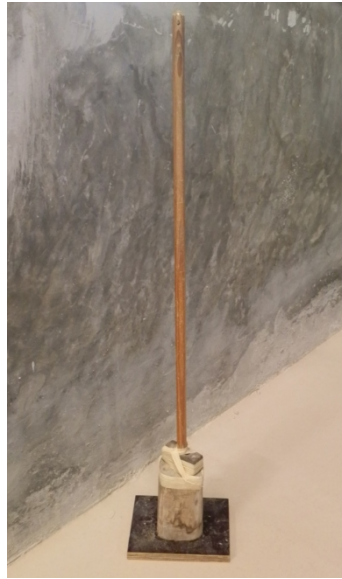
Figure 3: Compactor of the 1<sup>st</sup> trial embankment.

Before the dam construction, two trial embankments were performed to ensure a proper compaction of them. The first trial embankment was performed using a wood rod with a sheaf coupled to a wood plate at a bottom with a 10 cm layer thickness and the second was performed by a slick roller without vibration. Further details are given in Bento (2013).

The embankments of each dam-breach experiment were, therefore, performed using the compactor of the 1<sup>st</sup> trial embankment (see figure 3), although applying different compaction energies. The first considered four blows in each layer whilst in the second twelve blows were applied in order to study the density effects. For the type of soil in study, it was specified that the degree of compaction for the second embankment should show a minimum of 85% and a water content within the interval  $w \in [w_{optimum}, w_{optimum} + 2\%]$ .

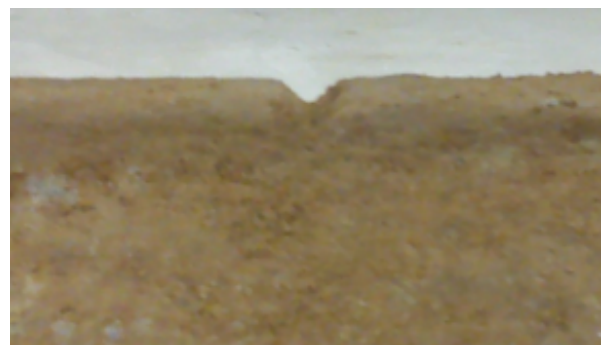
Figure 8: Photo of the pilot channel of the second embankment.

The initial breach geometries of each embankment are shown in figures 6 and 8, respectively.

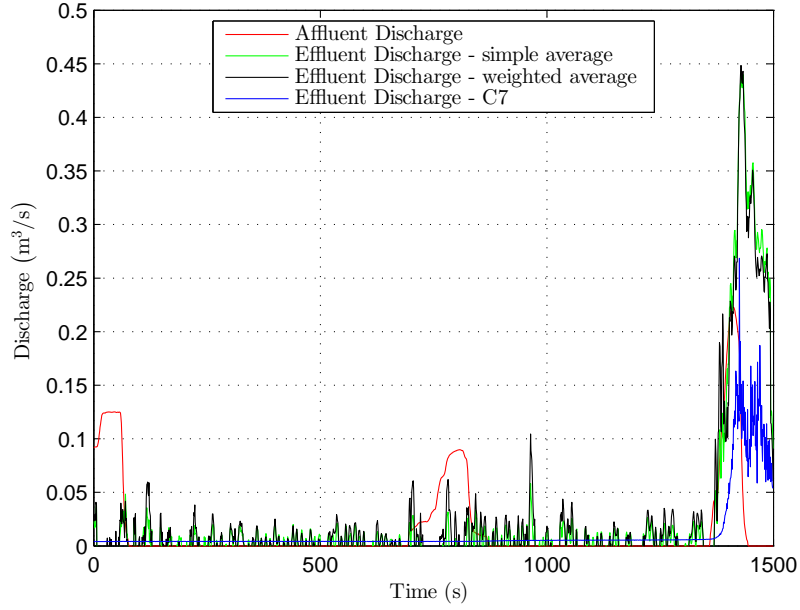
Figure 11: Breach effluent discharge estimations of the first experiment.

The breach effluent hydrographs obtained for each dam-breach experiments are represented below (Figure 11 and 12, respectively).

These two plots show different behaviours. In the first (Figure 11) is evident a very rapid breaching development, with the detachment of large masses of soil, which evolved to a relatively large size of the final breach. In this case, the effluent discharge reached a peak in a very short time and then the hydrograph suffered a dramatic drop. This result may be a result of the low compaction energy applied during the respective embankment construction.

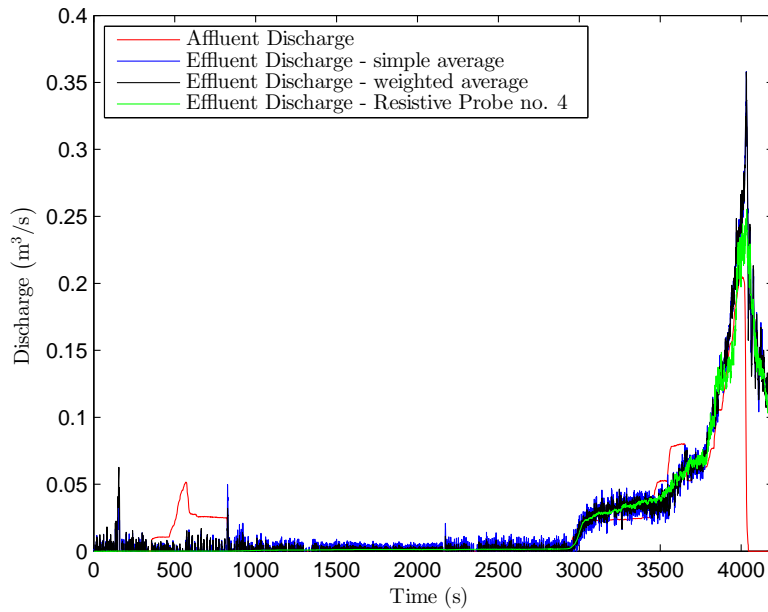
Figure 12: Breach effluent discharge estimations of the second experiment.

The hydrograph of the second experiment (Figure 12), using another energy of compaction and another initial geometry for the pilot channel showed a slow increase of the effluent discharge and a peak discharge

of less magnitude, when compared to the obtained in the first experiment.

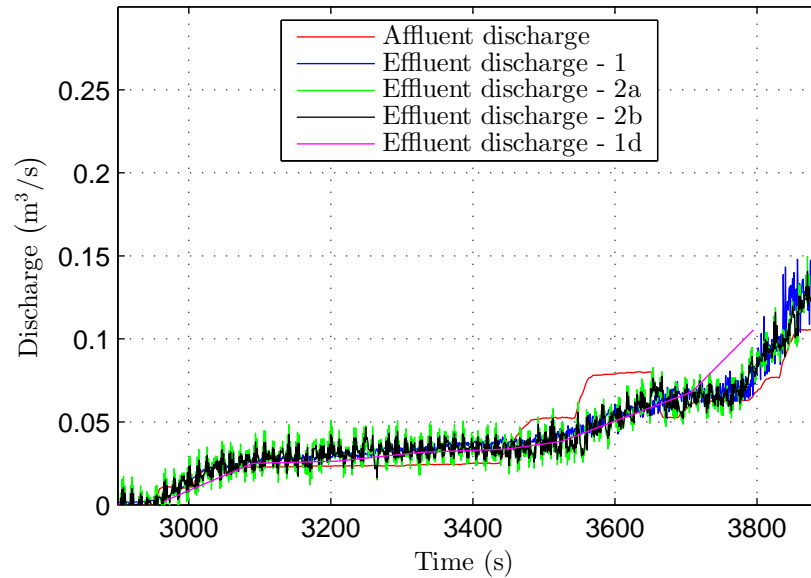
Figure 13: Comparison between the indirect estimations and the direct estimation (1d).

The direct estimation of the effluent discharge for the second dam-breach experiment, represented in figure 13, shows a very similar behaviour to the indirect estimations, although for only a restricted temporal interval was possible to perform that estimation.
