Lisbon's centenary Power Plant – Central Tejo – Characterization of materials and anomalies

Abstract

Central Tejo was the first thermoelectric plant operating in Portugal with a period of activity between 1909 and 1972. In order to meet high levels of power demand throughout its period of operation several extensions and modifications occurred.

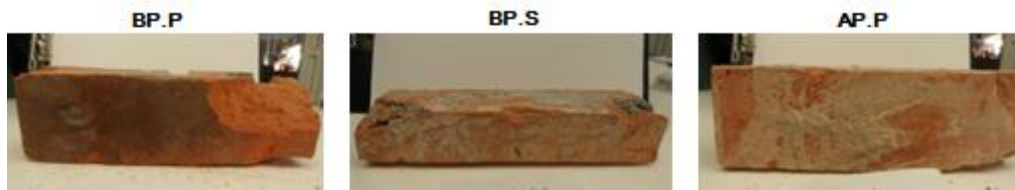
Figure 3 – Original bricks.

Samples of new bricks applied as replacement bricks, as well as original bricks that had already been removed from the façades during the last intervention (2011) were analyzed. More in detail, original samples from the South and West façades of the BP Building were characterized, **BP.S** and **BP.P** respectively, and from the West facade of the AP Building (**AP.P**), **Figure 3**.

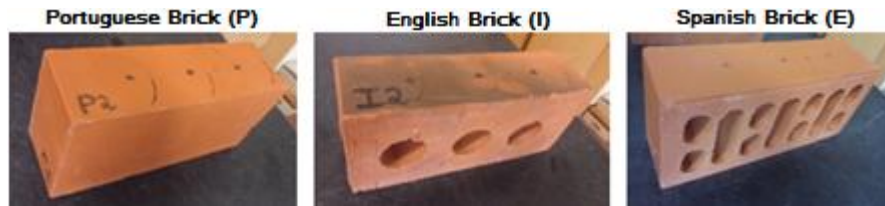
Figure 4 – Replacement bricks.

Regarding the replacement bricks three different types were evaluated, namely Portuguese (P), English (I) and Spanish (E), being the first solid and the last two perforated, Figure 4.

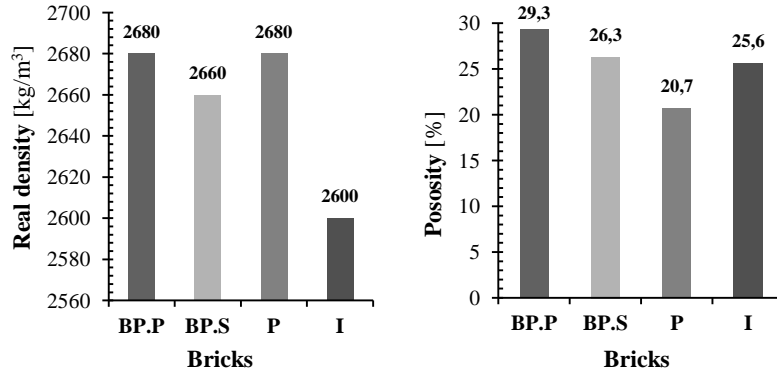
Figure 5 – Medium values of real density (left) and porosity (right).

Figure 5 presents the average values of the density and porosity obtained from the original bricks and replacement brick samples.

From the analysis of these results we conclude that the Portuguese type of replacement brick and the original bricks have very similar values of real density (2660 to 2680 kg/m³). These values are higher than those obtained for the English brick.

On two of the façades that were analyzed the original bricks generally exhibit higher porosity values than those obtained for the replacement bricks. In the West façade, the Portuguese brick has the lowest porosity of the whole sample (21%), while the English brick and **BP.P** present higher porosities, 26% and 29% respectively.

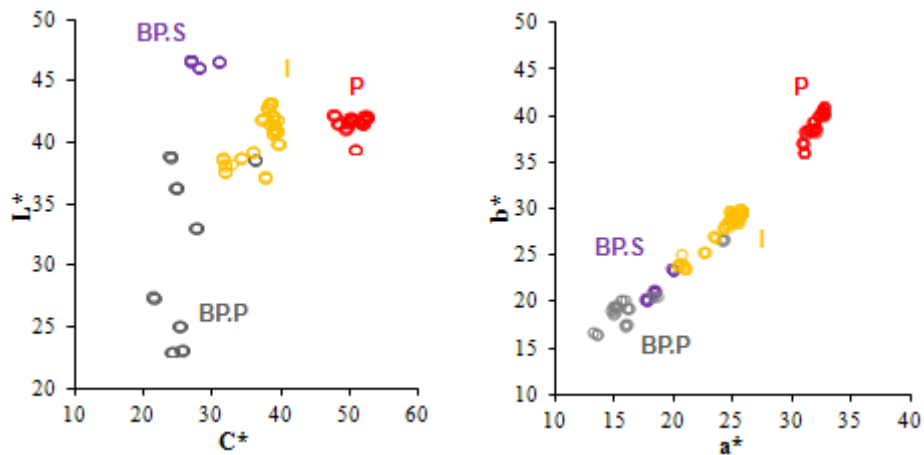
Figure 10 – Color of the tested samples. Luminosity (L^*) versus chroma (C^*) (left) and a^* versus b^* (right).

Figure 10 represents the colorimetric components of the bricks, plotted as L^* versus chroma, and the coordinate a^* versus b^* .

In the West facade the original brick manifest a smaller values of luminosity (L^*) than replacement ones, presenting also a higher variability in the sample. In the South facade the replacement brick shows slightly lower values of luminosity. In both cases the older bricks have lower values of chroma (C^*).

Regarding the a^* and b^* coordinates, in the West facade the English brick is closer to the sample of original brick, while the Portuguese brick is clearly further away, as it is also perceivable on the location.

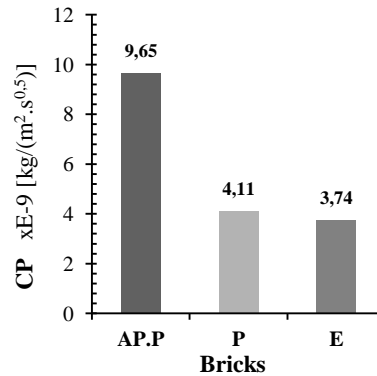
Figure 14 – Coefficient of water vapor permeability.

The values of the coefficient of water vapor permeability are presented on **Figure 14**. From the analysis of this figure it is clear that, the original bricks, in line of their higher porosity than replacement bricks, have also a higher value for vapor coefficient. Once again, the Spanish brick is the one with smaller water vapor permeability.
