Durability of GFRP pultruded profiles made of unsaturated polyester and vinylester resins

M.Sc. Dissertation Extended Abstract

February 2014

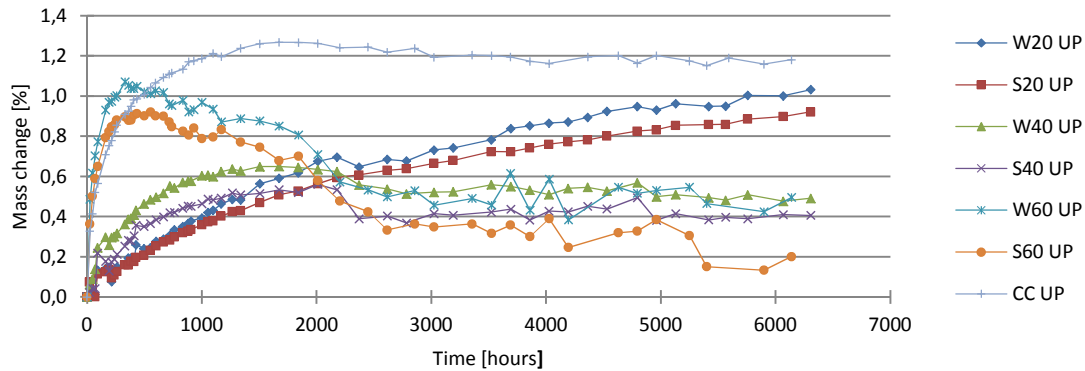
Figure 1 – Mass changes for different hygrothermal ageing conditions – UP profile

Figures 1 and 2 show the experimental curves of mass change for both UP and VE profiles, respectively, for different immersion media (W for demineralized water and S for salt water, at 20 °C, 40 °C and 60 °C) and continuous condensation (CC) at 40 °C.

Both profiles exhibited an approximately *Fickian* response, except for the immersions at 60 °C for the UP profile (and also at 40 °C although less significantly), in which significant mass loss was observed after a 400 hours exposure. According to Chin *et al.* [19], this phenomenon may be due to leaching of soluble degradation or hydrolysis products. Overall, demineralized water immersion exhibited greater mass uptake than salt solution immersion for each temperature. Elevated temperatures led to high initial mass change rates for both profiles and an overall greater mass uptake in the case of the

VE profile. The UP profile showed higher mass changes in comparison with the VE profile, with a maximum of 1,2 % for continuous condensation exposure, opposed to a maximum of 0,6 % for the VE profile (W60-VE).

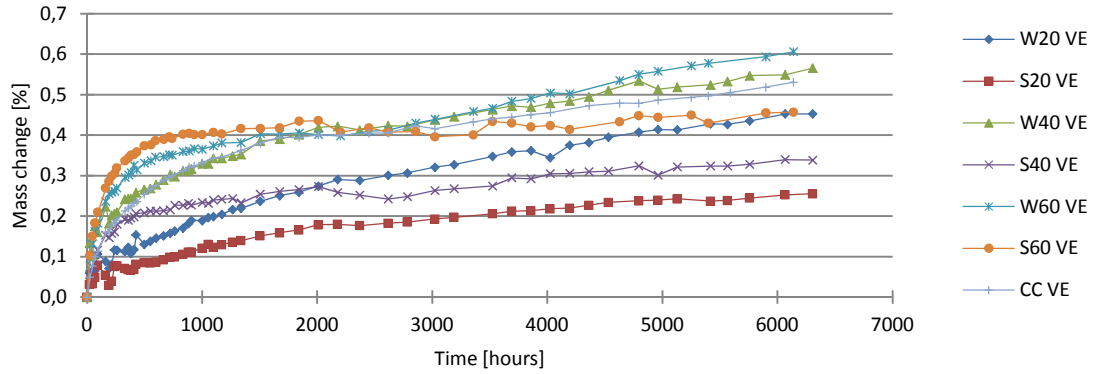
Figure 2 – Mass changes for different hydrothermal ageing conditions – VE profile

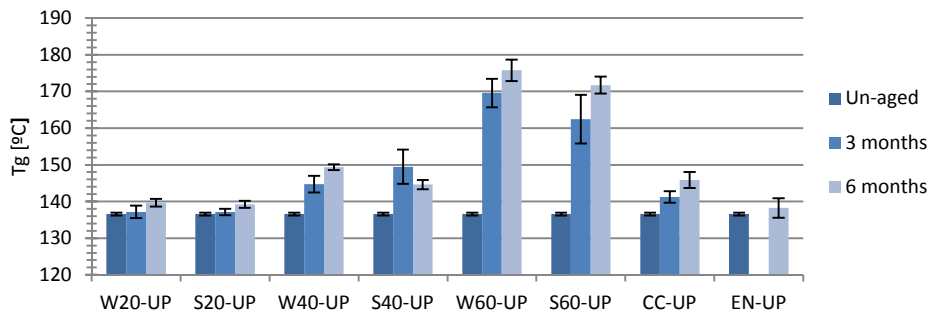
Figure 3 – T_g ($\tan \delta$) variation after hydrothermal ageing and natural weathering – UP profile

Figures 3 and 4 present changes in T_g ($\tan \delta$) for the UP and VE profiles, respectively, regarding hydrothermal ageing and natural weathering. Figure 5 plots changes in this property (for both profiles) after exposure to thermal cycles.

Obtained results show that, for both profiles, no significant degradation in glass transition temperature was experienced. According to Chu and Karbhari [20], water sorption leads to degradation in this property, due to matrix plasticization. However, drying of test specimens after ageing may have caused damage reversal.

Significant increases in glass transition temperature were exhibited after immersion at 60 °C, especially for the UP profile. This suggests that post-curing effects may have occurred despite the initial drying process. In the VE profile these effects were less significant, although some increases were observed. Irreversible degradation, which is expected to occur in most aggressive exposures, may have been outdrawn by these post-curing effects.

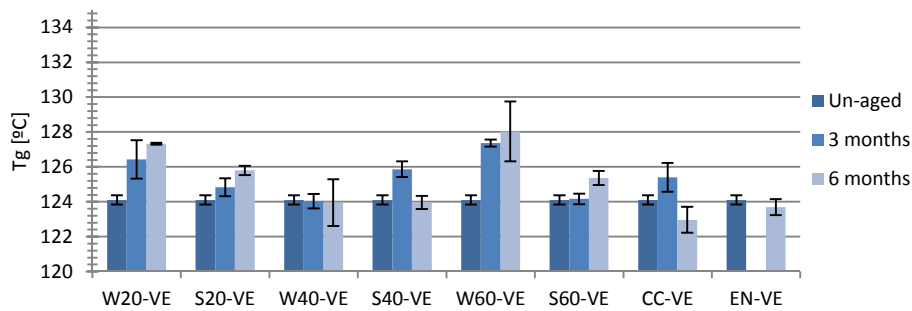
Figure 4 – T_g ($\tan \delta$) variation after hydrothermal ageing and natural weathering – VE profile

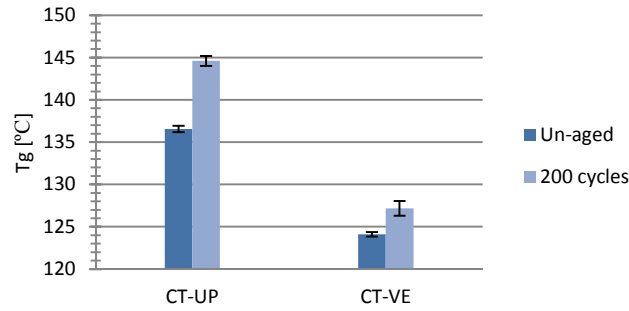
Figure 5 – T_g ($\tan \delta$) variation after thermal cycles – UP and VE profiles

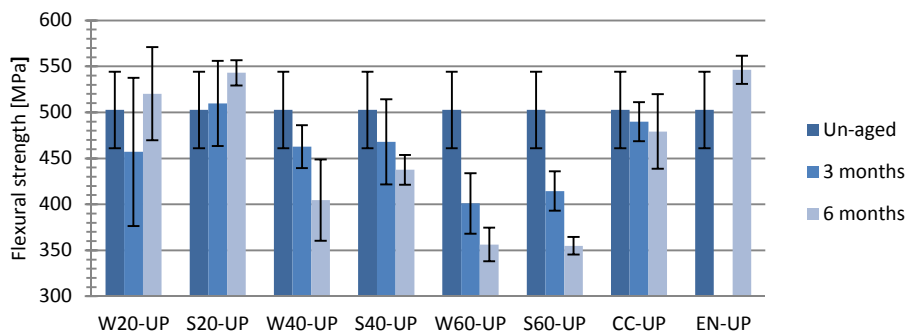
Figure 6 – Flexural strength changes after hygrothermal ageing and natural weathering exposure – UP profile

Changes in flexural properties for the UP profile after hygrothermal ageing and natural weathering exposure are plotted in figures 6 and 7. Changes for the vinylester profile are presented in figures 8 and 9. Figure 10 shows changes in flexural properties for both profiles, regarding exposure to thermal cycles.

Both profiles showed significant decreases in flexural strength, especially in the most aggressive environments, namely immersions at 40 °C and 60 °C. Losses were higher for the UP profile, with a maximum decrease of 29 % for immersion in both demineralized water and salt solution at 60 °C, which can be related to the mass loss phenomenon observed in this situation. The VE profile registered a maximum loss of 18 %, also in the immersion in demineralized water at 60 °C. Results suggest that irreversible degradation took place, more heavily in the immersions at elevated temperatures. Changes in flexural modulus were less significant for both profiles.

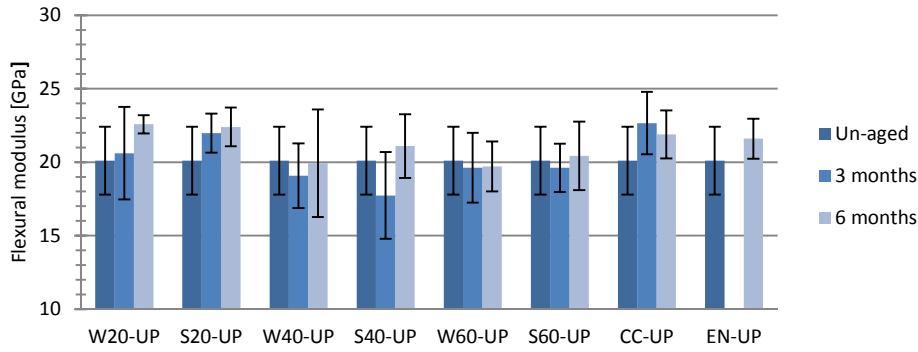
Figure 7 – Flexural modulus changes after hygrothermal ageing and natural weathering exposure – UP profile

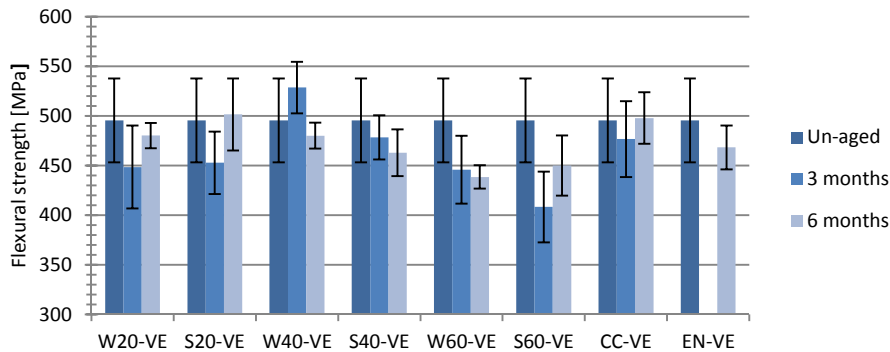
Figure 8 – Flexural strength changes after hygrothermal ageing and natural weathering exposure – VE profile

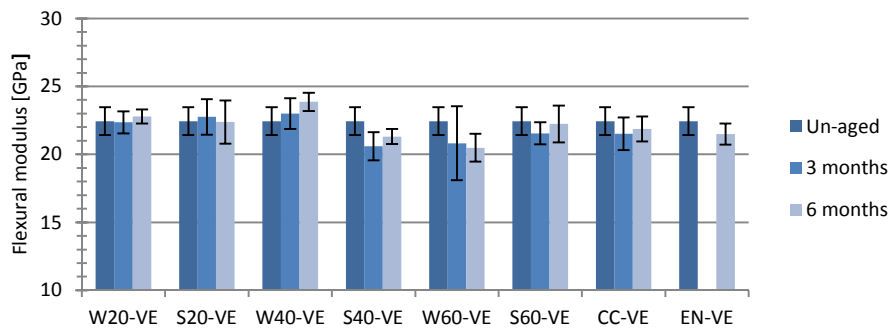
Figure 9 – Flexural modulus changes after hygrothermal ageing and natural weathering exposure – VE profile

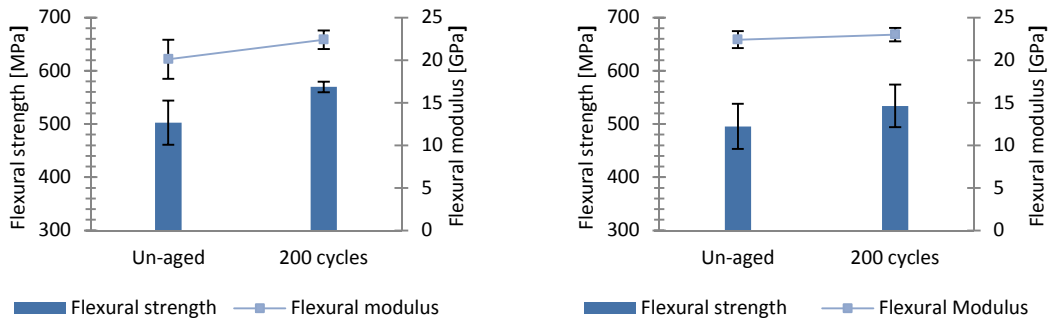
Figure 10 – Flexural strength and modulus after thermal cycles – UP (left) and VE (right) profiles

Exposure to thermal cycles caused slight increases in the flexural properties of both

profiles. According to Dutta and Hui [22], this kind of exposure may lead to the stiffening of the polymeric matrix and a consequent improvement in flexural properties.

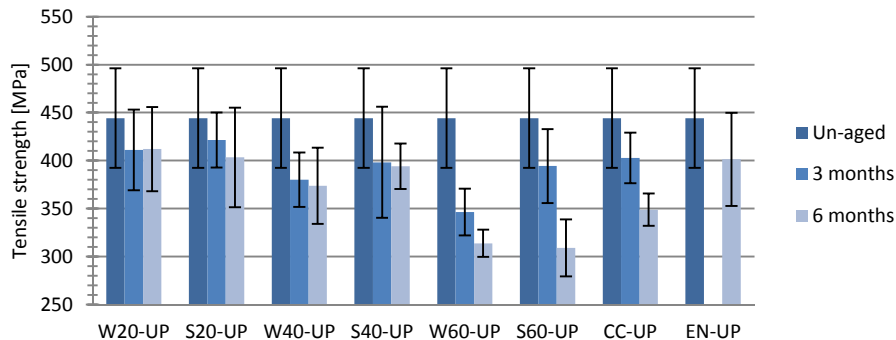
Figure 11 - Tensile strength changes after hygrothermal ageing and natural weathering exposure – UP profile

Figures 11 to 14 show changes in tensile properties for both profiles after exposure to hygrothermal ageing and natural weathering. Figure 15 plots changes regarding exposure to thermal cycles.

The UP profile showed an overall degradation tendency both on tensile strength and modulus, increasing with time and temperature. A maximum decrease of approximately 30 % was observed after 6 months of exposure to immersion in demineralized water and salt solution at 60 °C. Exposure to continuous condensation caused a decrease of 22 % in tensile strength, which suggests that the high moisture sorption observed may have caused irreversible degradation on the fiber and interphase levels. Regarding the VE profile, decreases in tensile strength were considerably lower, with a maximum loss of 9 % registered for immersion in demineralized water at 40 °C.

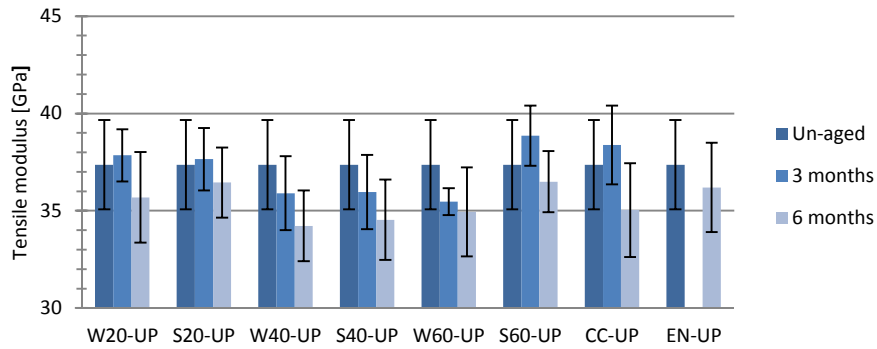
Figure 12 - Tensile modulus changes after hygrothermal ageing and natural weathering exposure – UP profile

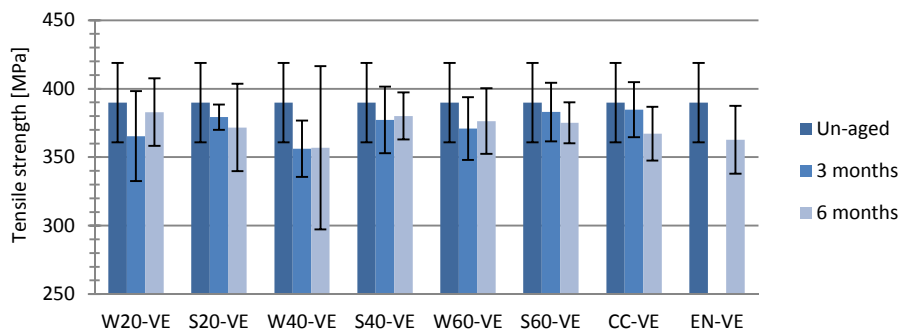
Figure 13 - Tensile strength changes after hygrothermal ageing and natural weathering exposure – VE profile

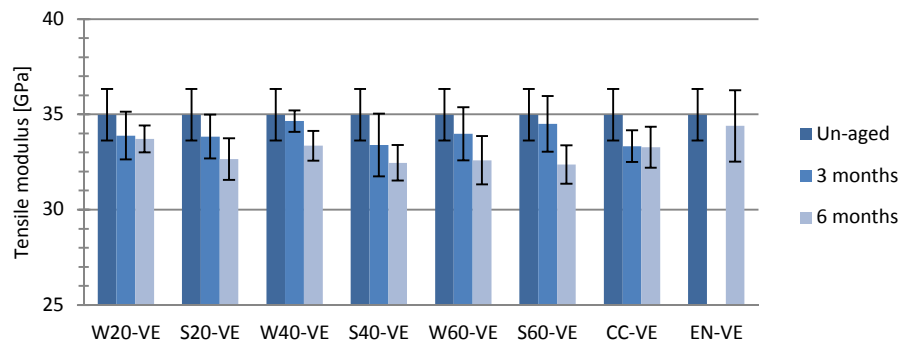
Figure 14 - Tensile modulus changes after hygrothermal ageing and natural weathering exposure – VE profile

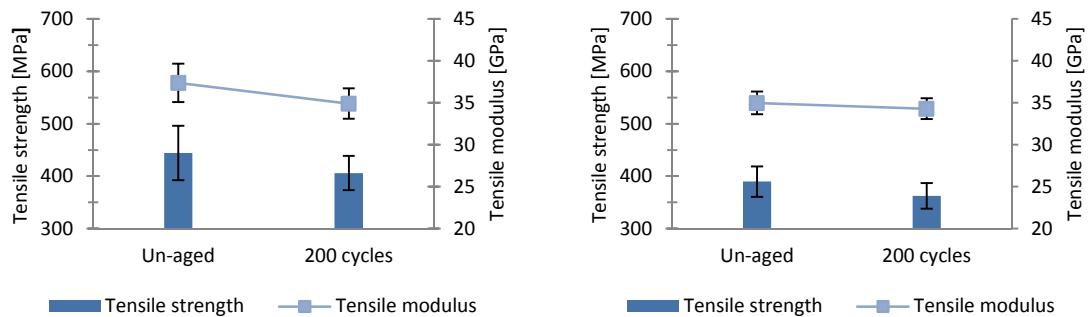
Figure 15 - Tensile strength and modulus after thermal cycles – UP (left) and VE (right) profiles

Exposure to thermal cycles caused slight decreases (under 10 %) in tensile strength and modulus for both profiles. According to Karbhari *et al.* [23], who observed similar losses for VE profiles in this kind of exposure, thermal cycles cause fiber-matrix debonding and matrix microcracking with consequent decreases in tensile properties.

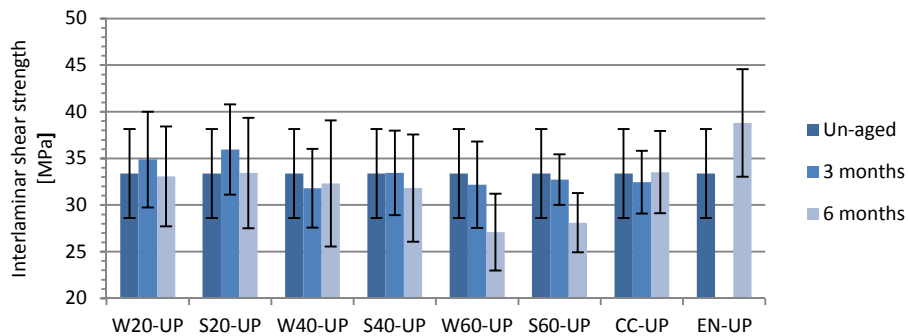
Figure 16 - Interlaminar shear strength changes after hygrothermal ageing and natural weathering exposure – UP profile

Changes in interlaminar shear strength are plotted in figures 16 and 17, for the UP and VE profiles, respectively. Figure 18 shows changes in this property for both profiles after exposure to thermal cycles.

Results for the UP profile present relatively high scatter. However, a degradation trend is visible for the immersion in demineralized and salt water solution at 60 °C, which suggests irreversible damage may have occurred on the matrix or the interphase region. A maximum loss of 19 % was registered for a 6 months exposure to demineralized water at that temperature. Regarding the VE profile, losses were observed in all exposure environments, although maximum losses were smaller compared to the UP profile. This suggests that irreversible degradation occurred at some extent on all ageing

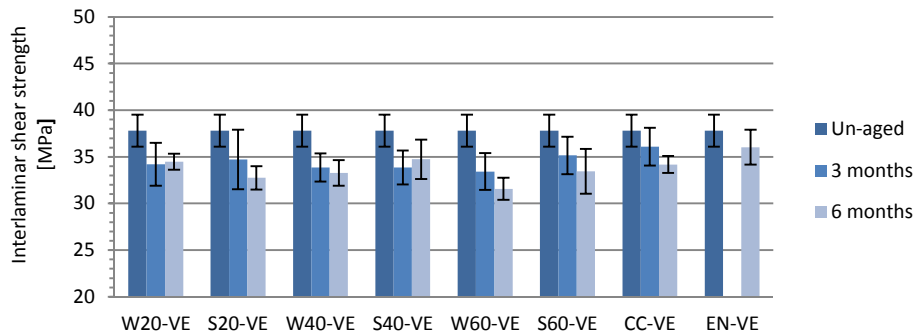
Figure 17 – Interlaminar shear strength changes after hygrothermal ageing and natural weathering exposure – VE profile

conditions for the VE profile. A maximum decrease of 17 % was observed for the VE profile, for the immersion in demineralized water at 60 °C.

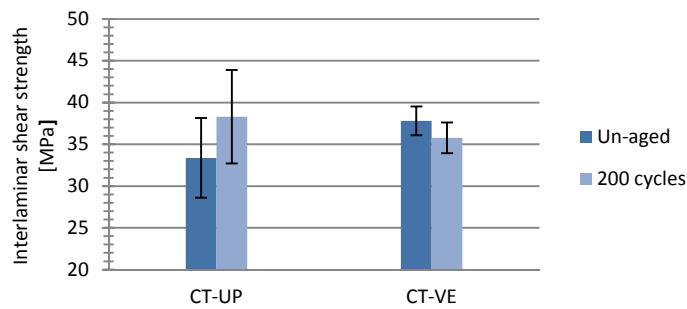
Figure 18 - Interlaminar shear properties after thermal cycles – UP (left) and VE (right) profiles

Thermal cycles originated contradictory results on both profiles, with an increase of 15 % for the UP profile (although associated to high scatter) and a slight decrease for the VE profile on this property.
