TECHNICAL UNIVERSITY OF LISBON
INSTITUTO SUPERIOR TÉCNICO

EXTENDED ABSTRACT

TECHNOLOGY AND REHABILITATION OF INNER GYPSUM PLASTERS

FILIPE MIGUEL DO CARMO FURTADO BRANDÃO PALHA

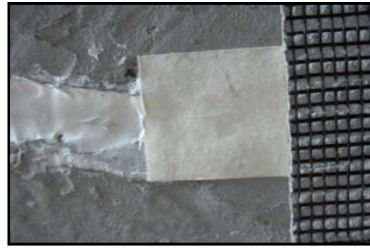
Figure 5: Local detachment of gypsum plaster and reinforcement with net (**R-D1**)

Local detachment of gypsum plaster (R-D1, Figure 5) is also a method used to repair unstable fissures caused by the movements of the support. This operation requires gypsum plaster's extraction up to the support in stripes of 25 cm to each side of the fissure, then it's fulfilled. Afterwards, gypsum plaster is disconnected from the support in the fissure's area and a detachment ribbon is applied upon it. Next, gypsum plaster is installed back to its place with a reinforcement net added, which will have a fold in the area upon the fissure. This method is more efficient, although it is much more limited in terms of the setting field in what regards **R-C2 technique (net incorporation in the regulating coat of the IGP)**, because it not only

increases the resistance to gypsum plaster's traction, but also allows the distribution of induced effort by the support's movement in a larger stripe of the cladding.
