**Methodology to assess microbiological colonization on
ETICS façades**

Thesis to obtain the Master of Science Degree in
Civil engineering

ETICS, Microbiological growth, Type of stain, Visual assessment, Diagnosis method

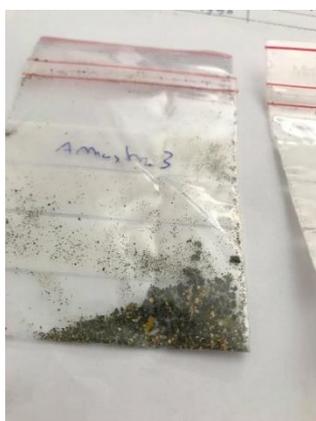
Figure 4.12: Sample 3 (area 1) northeast, side of Lot No. 11

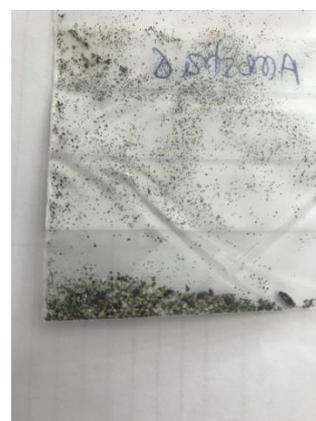
Figure 4.13: Sample 6 (area 3) northeast, side of Lot No. 67

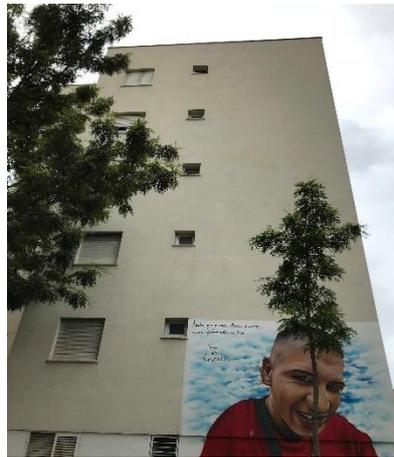
the atmospheric pollutions of other particles in the air. The stains are located on the free surface and were really small. Mechanical anchors that hold the insulation panels may be a reason for the oxidation stains. The size of the anchors is small and so are the stains, hence this estimation. The cracks (Figure 5.4) were only observed on façades facing southwest, both on the free surface and on the windowsills. There were several types of cracks, such as horizontal, vertical and mapped. The crack width, measured by a crack width gauge (Figure 5.5), are <0,5 mm. Due to the inaccessibility of the façades, the measurements could not be accurate enough. There is a difference between graffiti like art and graffiti like bombing. Figure 5.6 shows that it is indeed art, so it is not an anomaly.

Figure 5.6: Graffiti as art and not bombing

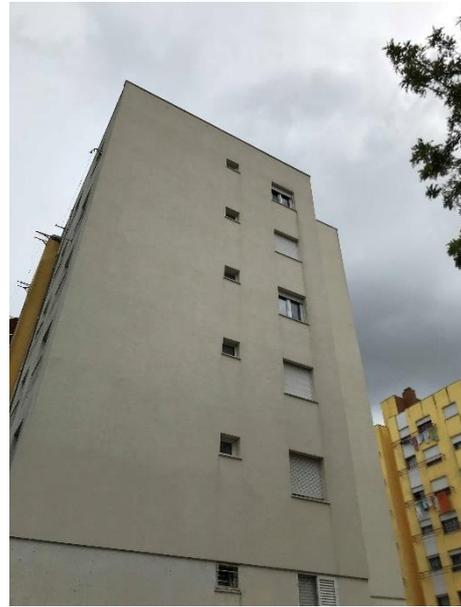
Figure 5.10: Side of Lot No 65, acrylic paint

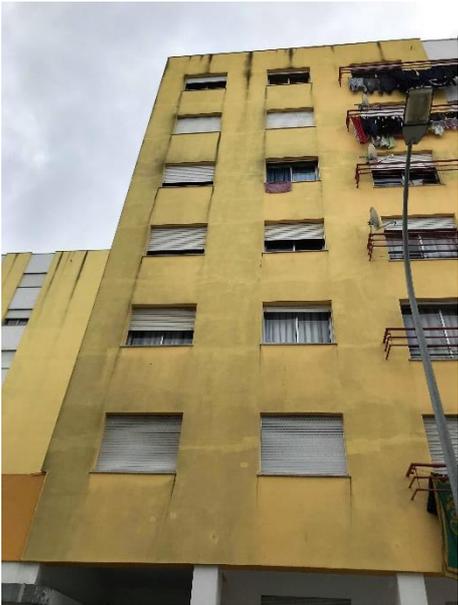
A longer exposure to solar radiation will lead to a faster drying process, which will strongly reduce the uniform stains in particular. Figure 5.14 and 5.15 are pictures with a different orientation, to show the difference. The main difference is mainly in the visibility/presence of the uniform stains. Figure 5.14 contains no uniform stains under the windows and next to the windows, but it is difficult to explain the cause of this.

Figure 5.14: Front of Lot No. 21, northwest

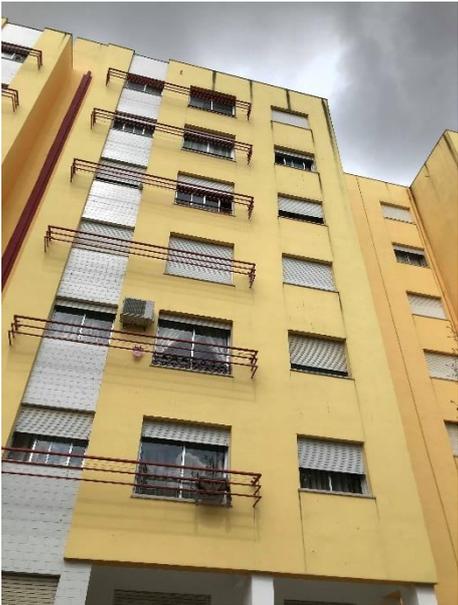
Figure 5.15: back of Lot No. 23, southeast

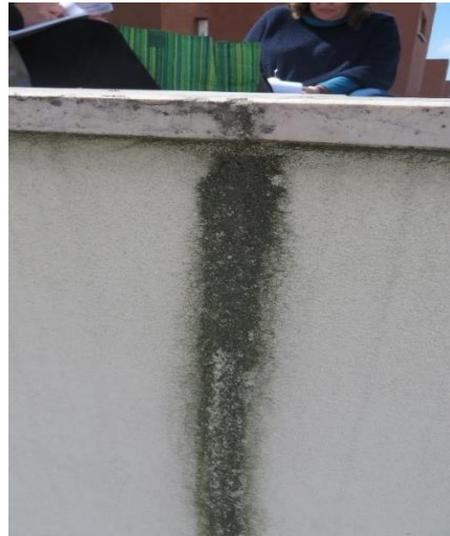
According to the proposed methodology, the results of the different steps (2.1 until 2.5 on Figure 4.1) will be discussed. It was not possible to get closer to the stains from the street, but it was possible to see them from the roof. Figure 5.17 shows a differential stain at the location of the roofing and is the result of poorly executed construction details or choice of material. The movement of rainwater on the façade will lead to deposits of stains at different locations. From below, the stains only appeared to have a dark colour, but from up close, several colours can be observed immediately. Sample 2 and 3 both have a yellow, grey, brown and black colour, where the yellow colour indicates lichen. The other parts can be dirt or other types of biological colonization. Figure 5.18 is taken on the roof of Lot No. 67 and also here differential stains are present. In comparison with the previous figure, the stain looks different. It no longer contains lichen, the possible options according to Table 3.1 are either algae, or fungi. As mentioned in 5.2.2.1, the type of biological colonization, the difference in colour or the amount of the stains can be different due to the finishing coating or even the underlying layer. Because the façade of area 3 does not have any similarities with the characteristics of lichen, it is possible that the coating (acrylic) is not an ideal substrate for this type.

Figure 5.18: Biological colonization on the side of Lot No. 67

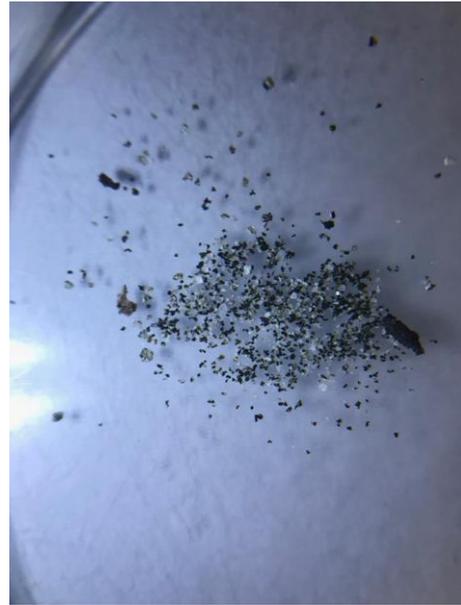
The first diagnosis method is the test with the magnifying glass, this glass has a magnification of 3.5x. As mentioned on Figure 4.1, is it possible to do the test in-situ or in the lab. Figure 5.19 and 5.20 are results of sample 2 and 6 carried out in the lab. Due to the poor quality of the pictures, not all results will be shown and discussed. These kind of method is limited because of the fixed magnification, but an attempt could be made to distinguish the shape and colour of the particles. In sample 2, yellow, grey and black colours can be observed and are larger in shape. Sample 6 contains black, white and green colours, but the particles are very small. With this test different types of biological colonization can be distinguished based on the shape and colour, but certainly not all particles in the samples. The different types can be due to the material of the finishing coating and possibly the underlying layer or the orientation, as discussed in 5.2.2.1 and 5.2.2.2

Figure 5.20: Result magnifying glass sample 6

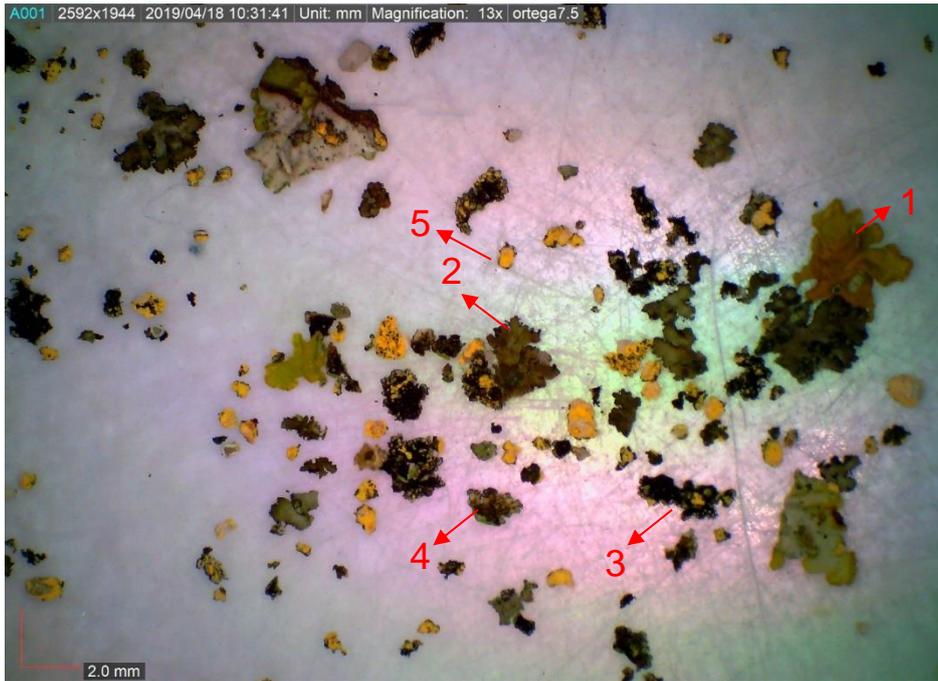
Figure 5.22 shows the result of the digital microscope (magnification 13x) and Figure 5.22 is the result after adding a drop of bleach (magnification 13x). The only type of biological colonization recognized during the visual assessment was lichen because of its yellow colour and shape. The extra magnification due the digital microscope allows colours and the shape of the particles to be better distinguished. At first sight there are four different types present. The number 1 indicates lichen, the numbers 2 to 5 can be algae, fungi or dirt. Of the types 1, 3, 4 and 5 can already be said with certainty that it is not dirt but microbiological growth. Type 2 has a light brown colour and dirt particles range from light brown to black. The results of the bleach test will further show if this determination is correct. Compared to the particles in Figure 5.23, all the types including type 2 have changed colour. A short overview of the colour changes is given below:

Type 1 (Lichen): Yellow → red/green
Type 2: Light brown → green
Type 3: Black/yellow → green at the edges
Type 4: Brown/grey → brown/green
Type 5: Yellow → green/red at the edges

Figure 5.22a: Result of sample 2 without bleach, magnification 13x

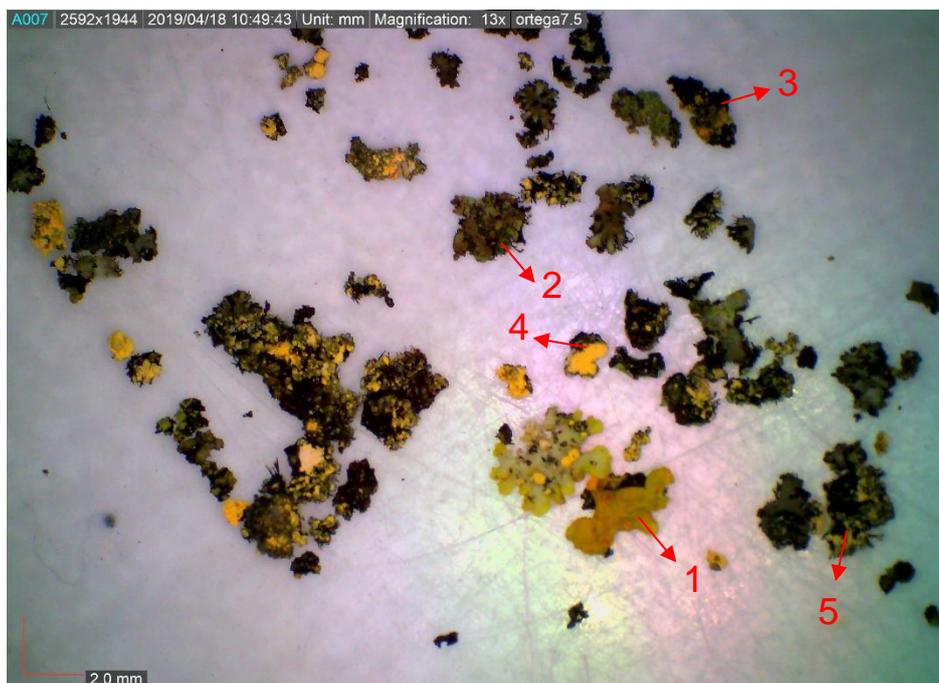
Figure 5.24 shows the result of the digital microscope (magnification 13x) and Figure 5.25 is the result after adding a drop of bleach (magnification 13x). Again, a type of biological colonization, lichen (number 1), was detected during the observation. It is noticeable that the particles of sample 3 are very similar to

those of sample 2. The samples come from the same building with the same materials used for the ETICS. The shape and colours of the particles are very similar to those of Figure 5.22. The uncertainty about the numbers 2 to 5 also applies here, these can be algae, fungi or dirt. Due to the result of sample 2, dirt can probably be excluded. Because of the similarities with sample 2, these particles should also discolour after the bleach test. This result is confirmed on Figure 5.25, where everything has changed colour, only with type 5 the colour difference is difficult to detect. If a very close look is taken, a red colour can be seen at the edges. For sample 3 we also made a short overview with the colour changes:

Figure 5.24a: Results of sample 3 without bleach, magnification 13x

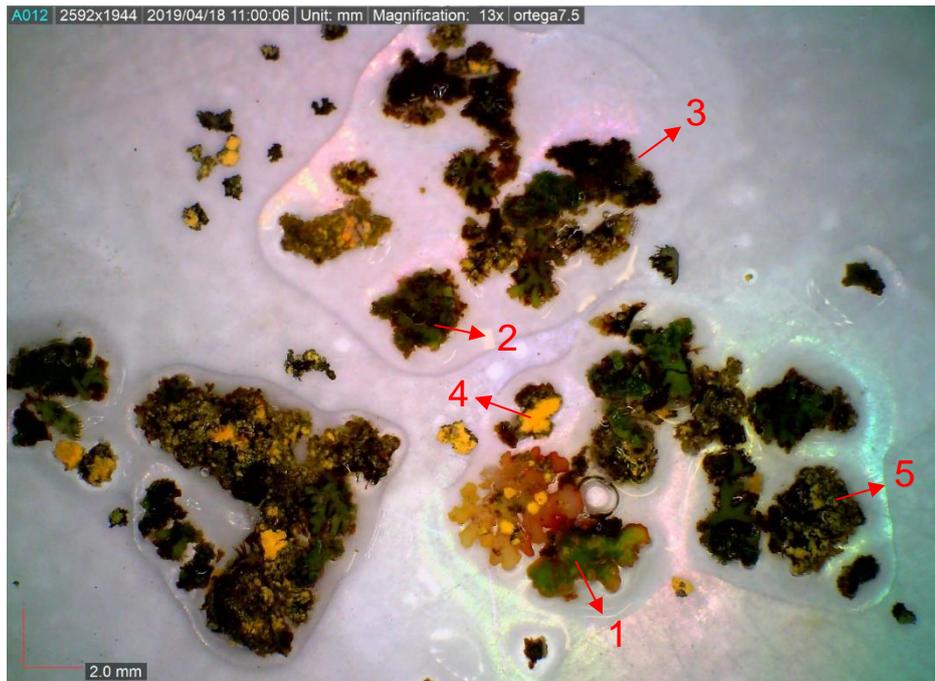
Type 1 (Lichen): Yellow → red/green
Type 2: Brown/green → green and yellow/red at the edges
Type 3: Black/yellow → black/red/green
Type 4: Yellow → green/red at the edges
Type 5: Black/green-yellow → Red at the edges

Figure 5.25b: Result of sample 3 with bleach, magnification 13x

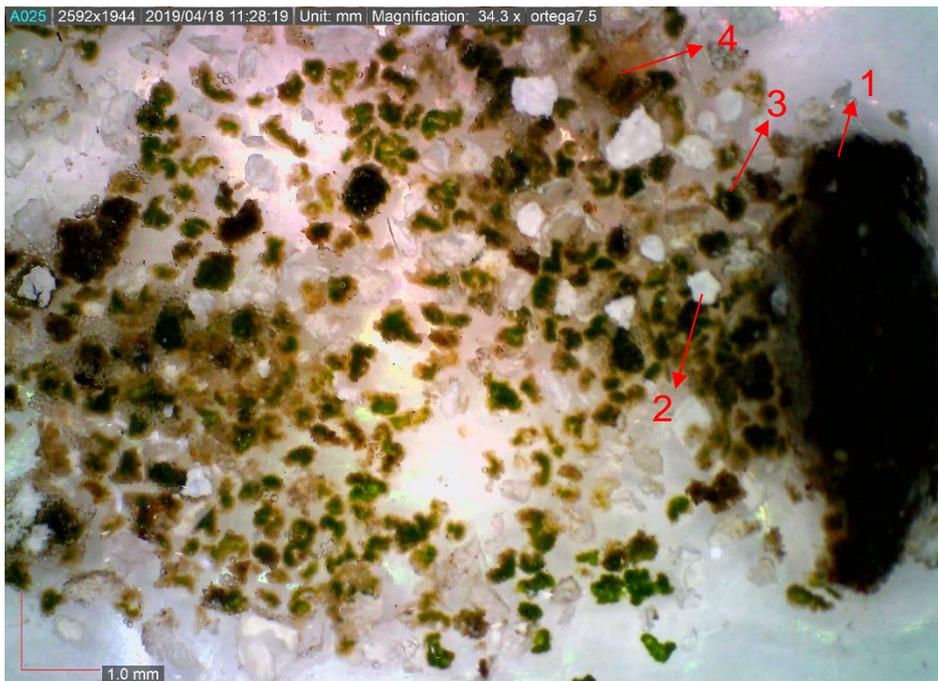
Figure 5.26 is the result with a magnification of 26.5x and Figure 5.27 is the result after adding a drop of bleach (magnification 34x). Because of the small size of the particles a large magnification was chosen. Due to the lack of a picture with the same magnification, an indication was made on Figure 5.26, on which the bleach test will be performed. In comparison with the previous 2 samples the particles are different, this may indicate new types of biological colonization. Lichen can already be excluded because there are no similarities in the structure and colours. At first sight, four different types were identified with the microscope. Type 1 has both large and small particles and a red/black colour (other colours are difficult to perceive). Type 2 has a crystalline structure and white (sometimes in combination with a green/brown). Together with type 2, type 3 is common, they are green particles in the form of very small leaves. Type 4 has an orange/reddish colour and appears only once in the sample. After the bleach test all types got a different colour, but with type 2 there is sometimes confusion. Some particles seem to keep the white colour, but others have a brown/yellow shine. The white particles can be paint, by scrapping on the façades. The colour changes are summarized in the overview below:

Figure 5.27b: Result of sample 6 with bleach, magnification 34x

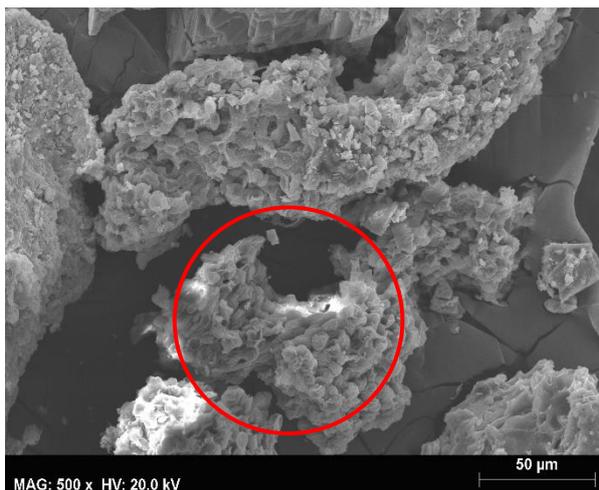
Figure 5.45 and 5.46 are the results of an investigation in another area of sample 6. Compared to the previous area, the particles do have a similar structure. If a very close look is taken at Figure 5.46 (enlargement area in circle), it seems to be the same type of structure as the previous one. The particles, which sometimes have a spherical structure, contain very small dots. These results are from a different area but show the same result. The number of different types of biological colonization may be more limited in this sample.

Figure 5.45: Sample 6 (area 2), magnification 500x
